Manhole Inspection Summary

Manhole # **S35C__026MH**

Insp Date: **11/14/08 12:49 PM**

Location Address: **1 N Charles St**

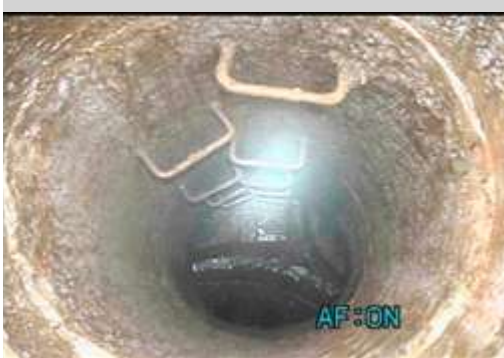
Defect 1

Count: **9** Missing: **0** ☒ **Corroded**

steps corroded

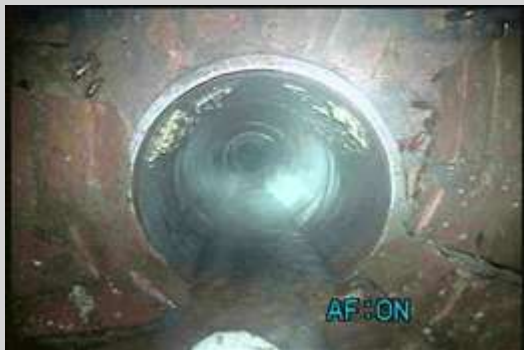
12 O'Clock Outflow

10 in. Circular Gravity Sewer
Pipe Out @ 12 O'Clock

Invert Depth: **14.90** (ft.) Flow Characteristics: **Slow**

Deposits: ☒ None ☐ Mud ☐ Sludge ☐ Debris ☐ Grease

Infiltration: **None** Pipe Seal Cond: **Unknown**

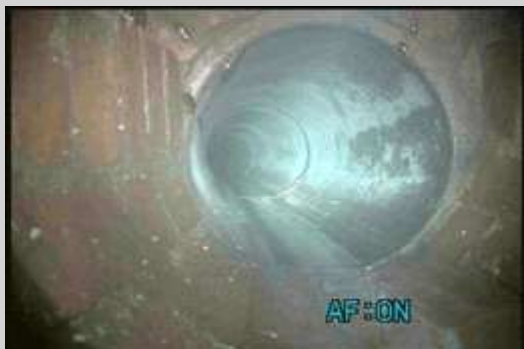
5 O'Clock Inflow

10 in. Circular Gravity Sewer
Pipe In @ 5 O'Clock

Invert Depth: **14.75** (ft.) Flow Characteristics: **Slow**

Deposits: ☒ None ☐ Mud ☐ Sludge ☐ Debris ☐ Grease

Infiltration: **None** Pipe Seal Cond: **Unknown**

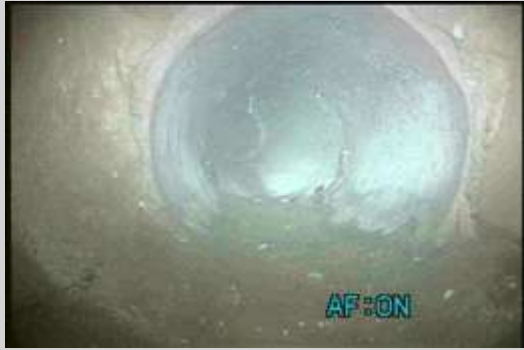
9 O'Clock Inflow

8 in. Circular Gravity Sewer
Pipe In @ 9 O'Clock

Invert Depth: **14.41** (ft.) Flow Characteristics: **None**

Deposits: ☒ None ☐ Mud ☐ Sludge ☐ Debris ☐ Grease

Infiltration: **None**
